INDOOR AIR QUALITY ASSESSMENT

**Green Meadow Elementary School
Great Road
Maynard, Massachusetts**

Prepared by:
Massachusetts Department of Public Health
Bureau of Environmental Health Assessment
June, 2002

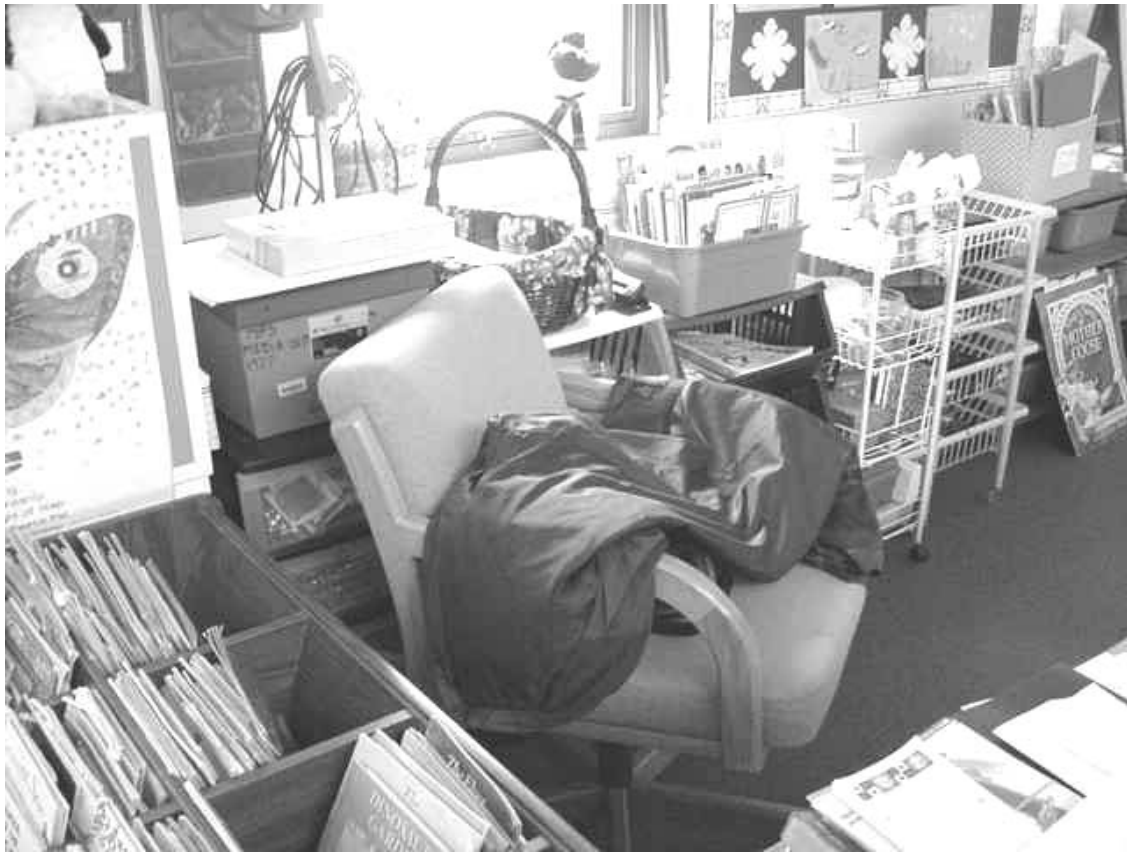
Picture 1

Fresh air in classrooms is supplied by wall-mounted unit ventilators (univents) (see [Figure 1](#)). Univents draw air from outdoors through a fresh air intake located on the exterior walls of the building and return air through an air intake located at the base of each unit. The mixture of fresh and return air is drawn through a filter and a heating coil, and is then expelled from the univent by motorized fans through fresh air diffusers. Univents were not operating in a few of the areas surveyed (see Tables). Obstructions to airflow, such as books, papers and posters on top of univents, as well as desks and carts in front of univent return vents, were seen in a number of classrooms (see Picture 1). To function as designed, univent fresh air diffusers and return vents must remain free of obstructions. It is important that these units be activated and allowed to operate during school hours.

Materials Obstructing Airflow of Classroom Univent

1. Examine each univent for function. Survey classrooms for univent function to ascertain if an adequate air supply exists for each room. Consider consulting a heating, ventilation and air conditioning (HVAC) engineer concerning the calibration of univent fresh air control dampers school-wide.
2. Activate exhaust ventilation in occupied areas. Repair and/or replace exhaust ventilation motors where necessary. Consider replacing wall switches controlling exhausts with key switches (see Picture 11 for an example).

3. Remove all blockages from univents and exhaust vents to facilitate airflow.
Consider removing coat closet doors to prevent blockage or re-locating passive door vents to the top of coat closet doors to improve exhaust ventilation.

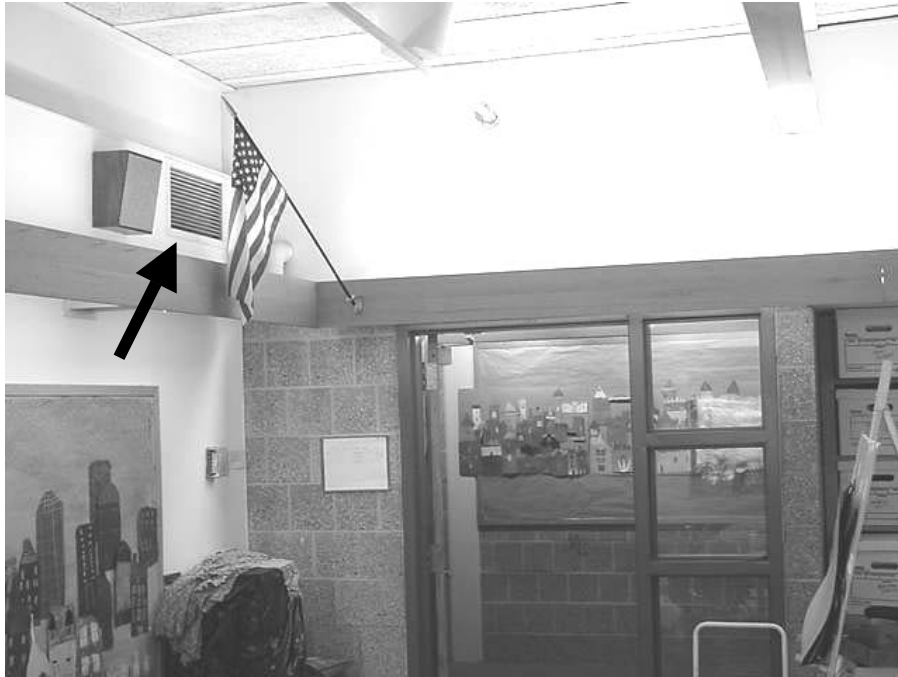
Picture 2

The mechanical exhaust ventilation system in the new addition consists of wall-mounted vents. The location of some exhaust vents can limit exhaust efficiency when the classroom hallway doors are open (see Picture 2). When a classroom door is open, exhaust vents will tend to draw air from both the hallway and the classroom. The open hallway door reduces the effectiveness of the exhaust vent to remove common environmental pollutants from classrooms.

Location of Classroom Wall Mounted-Exhaust Vent in Relation to Hallway Door

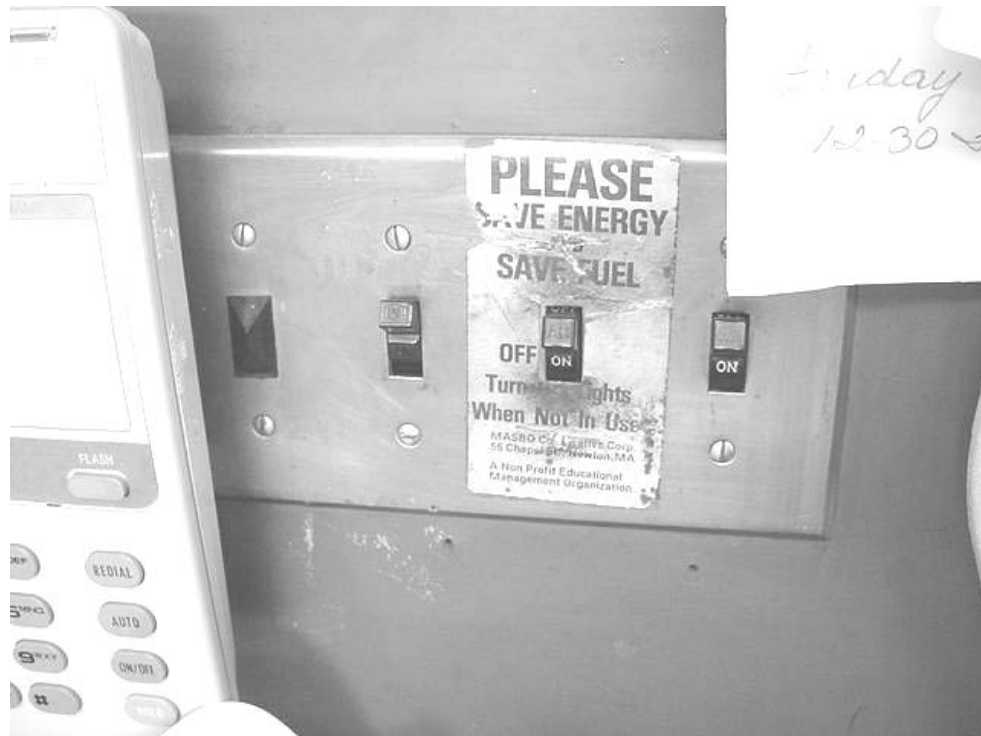
Picture 3

Exhaust vents in the original building are located in the ceilings of coat closets and are activated by wall switches (see Picture 3). A number of these vents were deactivated during the assessment. Without the exhaust system operating as designed, normally occurring pollutants cannot be removed allowing them to build up and lead to indoor air quality/comfort complaints. Classroom air is drawn into the coat closet via an undercut below the closet door. This design allows for the vents to be easily blocked by stored materials. In a number of classrooms, these vents were blocked with books, book bags, boxes and other obstructions (see Picture 4). In order to function properly, these vents must remain free of obstructions.

Classroom Wall Switch Controlling Exhaust Vent in Coat Closet

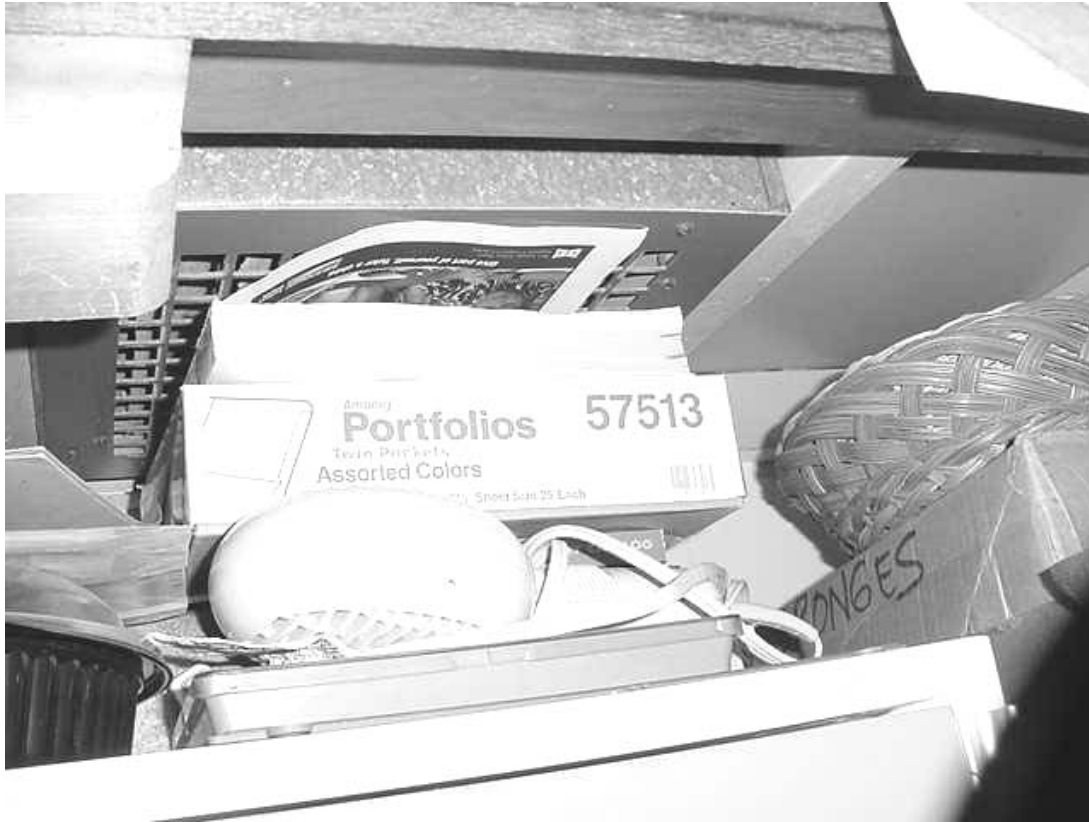
Picture 4

Coat Closet Exhaust Vent Blocked by Stored Items

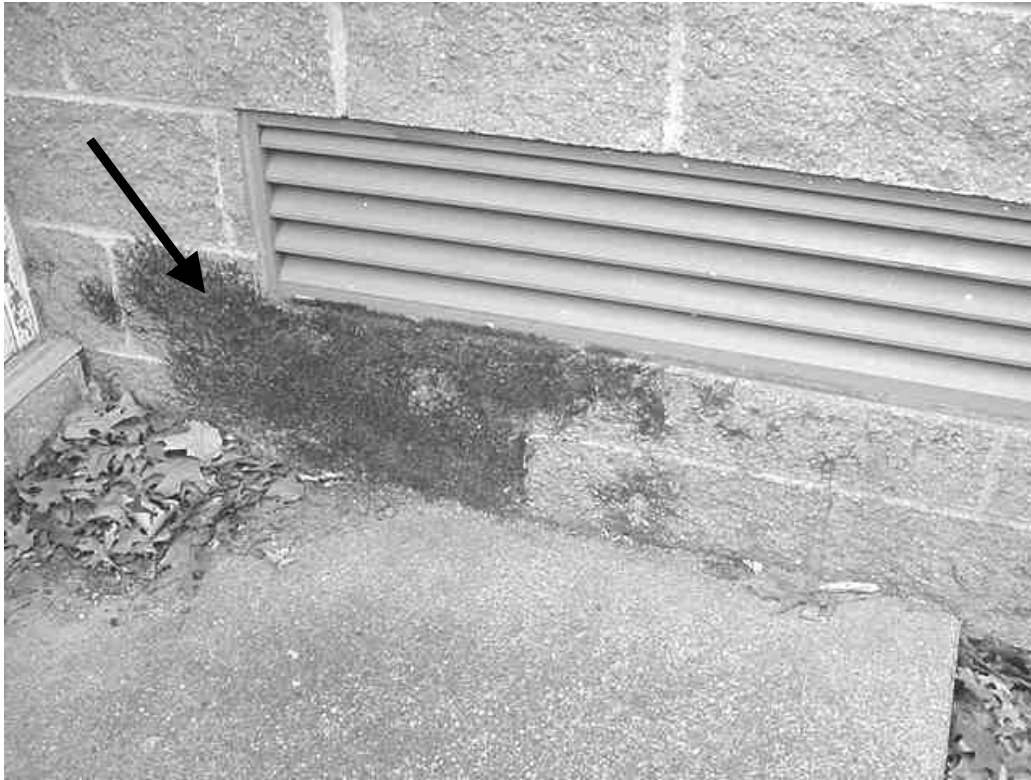
A perimeter inspection of the building was conducted in which BEHA staff noted a moisture penetration problem due to the lack of a complete roof drainage system. Picture 5 depicts a green organic material (possibly moss or algae) growing on exterior brickwork on the rear of the building. The pattern and location of growth is consistent in areas that are not equipped with gutters or downspouts. The lack of proper drainage allows back-splashing rainwater to impact on the ground below and chronically wet the exterior walls. Gutters and downspouts are designed to collect and direct rainwater away from the base of the building to prevent the chronic wetting of exterior walls which can result in damaged brickwork and/or mold growth. Over time rainwater can work its way into mortar and brickwork causing cracks and fissures, which can lead to water penetration as well as the increased degradation of the structural integrity of the building.

Moss Growth due to Splashback near Univent Air Intake on Rear of Building

9. Clean and maintain aquariums and animal cages to prevent bacterial/mold growth and/or odors.
10. Inspect/install drainage to prevent the impact of back-splashing rainwater on exterior brickwork. Remove growth and disinfect areas on exterior brickwork with an appropriate antimicrobial as needed.

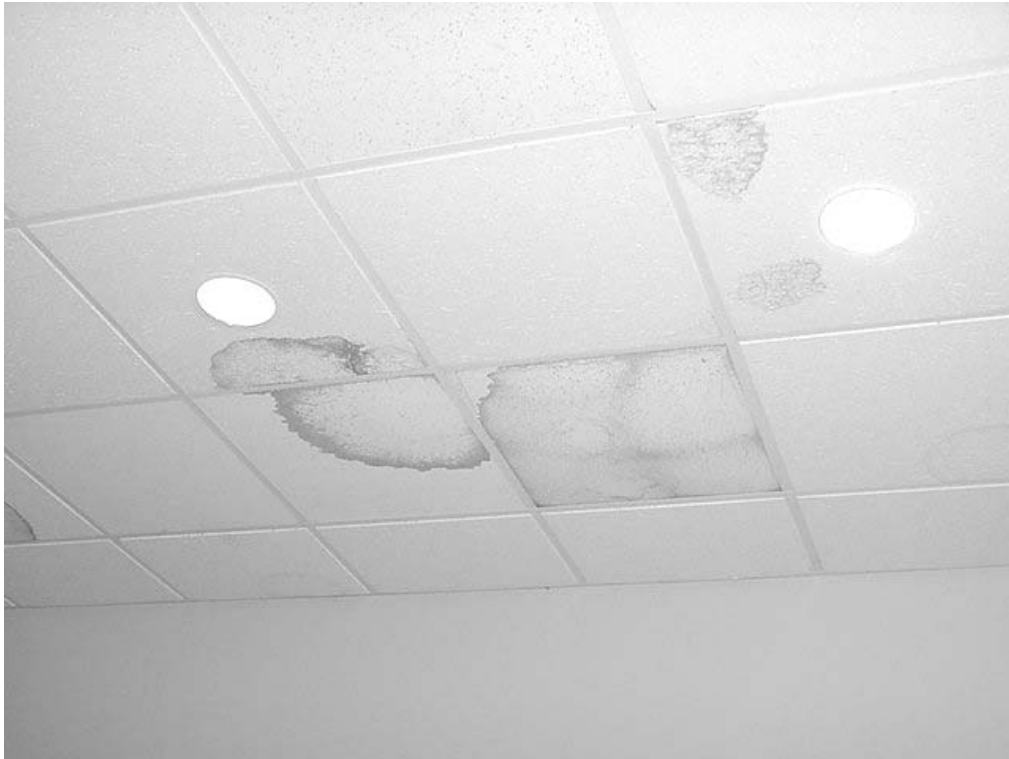
Picture 6

Some water-damaged ceiling tiles were noted resulting from historic roof leaks (see Picture 6). If wetted repeatedly, porous materials can grow mold and be a source of unpleasant odors. Water-damaged building materials should be replaced after a water leak is discovered. Water damaged ceiling tiles in the level three hallway and the carpeting directly below it, were tested for moisture content. No elevated levels of moisture were detected. The American Conference of Governmental Industrial Hygienists (ACGIH) recommends that carpeting be dried with fans and heating within 24 hours of becoming wet (ACGIH, 1989). If carpets are not dried within this time frame, mold growth may occur. Water-damaged carpeting cannot be adequately cleaned to remove mold growth.

Water Damaged Ceiling Tiles

8. Repair any water leaks and replace any remaining water-stained or missing ceiling tiles. Examine the areas above and behind these tiles for mold growth. Disinfect areas of water leaks with an appropriate antimicrobial.

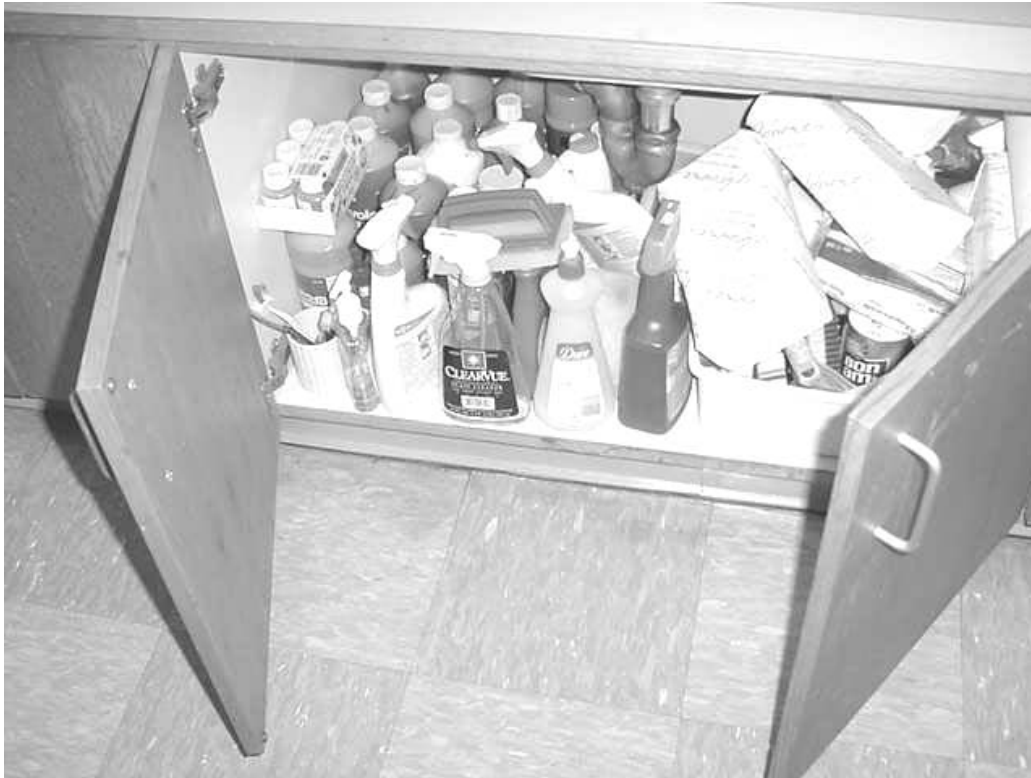
Picture 7

Several other conditions were noted during the assessment, which can affect indoor air quality. Cleaning products and other materials were found on counter-tops and beneath sinks in a number of classrooms (see Picture 7). Several classrooms also contained unlabeled spray bottles. Products should be kept in their original containers or

clearly labeled as to their contents for identification purposes in the event of an emergency. Cleaning products contain chemicals that can be irritating to the eyes, nose and throat of sensitive individuals.

Cleaning Products Stored beneath Unlocked Classroom Sink

11. Do not store paper products or other cellulose-containing materials beneath sinks.
12. Store cleaning products and chemicals properly and keep out of reach of students.
13. Relocate or consider reducing the amount of materials stored in classrooms to allow for more thorough cleaning. Clean items regularly with a wet cloth or sponge to prevent excessive dust build-up.
14. Ensure exhaust ventilation is functioning in areas that contain lamination machines and photocopiers.
15. Periodically clean exhaust vents of accumulated dust and debris.
16. Keep hornet/wasp's nest away from univents to prevent the aerosolization of potentially allergenic materials. Consider bringing in items on an "as needed" basis.
17. Do not activate kiln until local exhaust ventilation ductwork is properly installed.

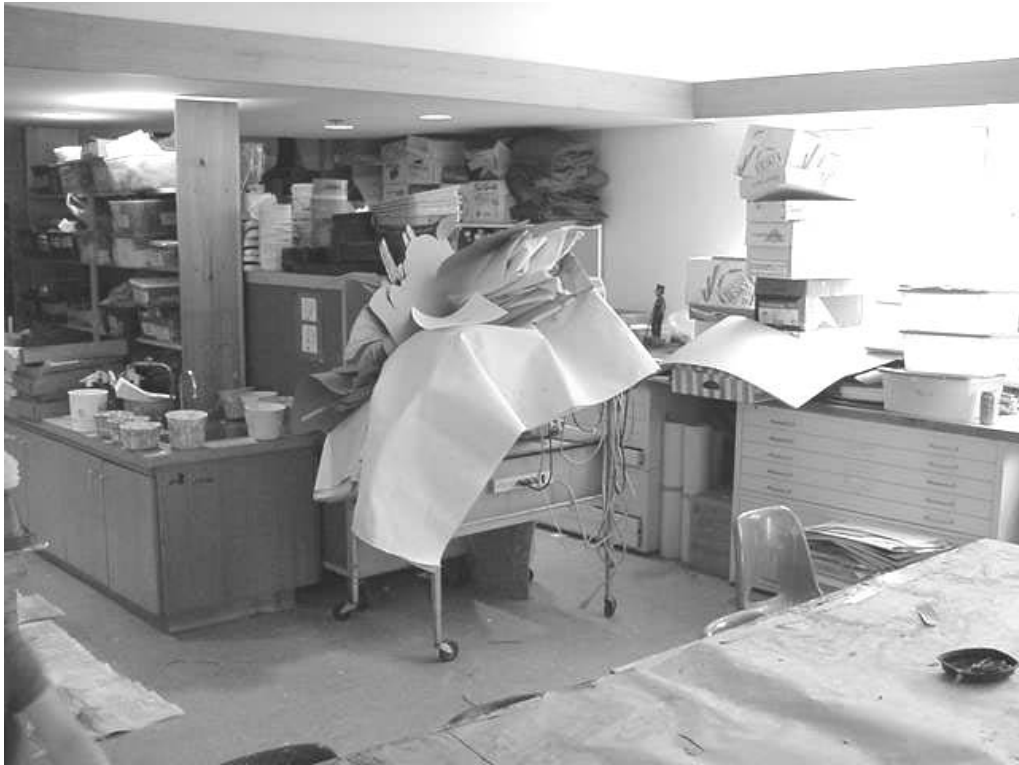
Picture 8

Also of note was the amount of materials stored inside classrooms. In classrooms throughout the school, items were observed to be piled on windowsills, tabletops, counters, bookcases and desks. The large number of items stored in classrooms provide a source for dusts to accumulate (see Picture 8). These items, (e.g., papers, folders, boxes, etc.) make it difficult for custodial staff to clean. Dust can be irritating to the eyes, nose and respiratory tract. These items should be relocated and/or cleaned periodically to avoid excessive dust build up. A number of exhaust vents in classrooms, restrooms and in common areas had accumulated dust on their grills. If exhaust vents are not functioning, backdrafting can occur, which can re-aerosolize dust particles. In addition, these materials can accumulate on flat surfaces (e.g., desktops, shelving, and carpets) in occupied areas and subsequently be re-aerosolized, causing further irritation.

Accumulated Items in Classroom

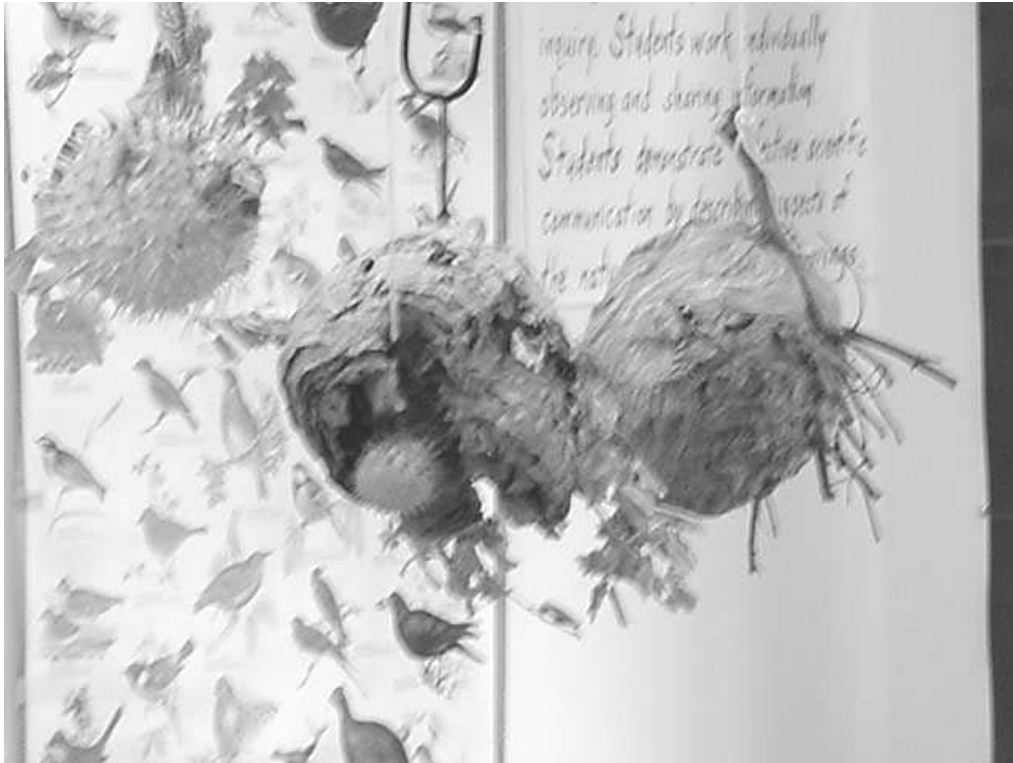
Picture 9

A number of display hornet/wasp's nests were noted in classrooms (see Picture

9). Several rooms contained animals such as lizards and hamsters. Animal dander and insect parts can become dried out, aerosolized and may serve as sources of allergenic material for sensitive individuals.

Hornet/Wasp's Nests in Classroom

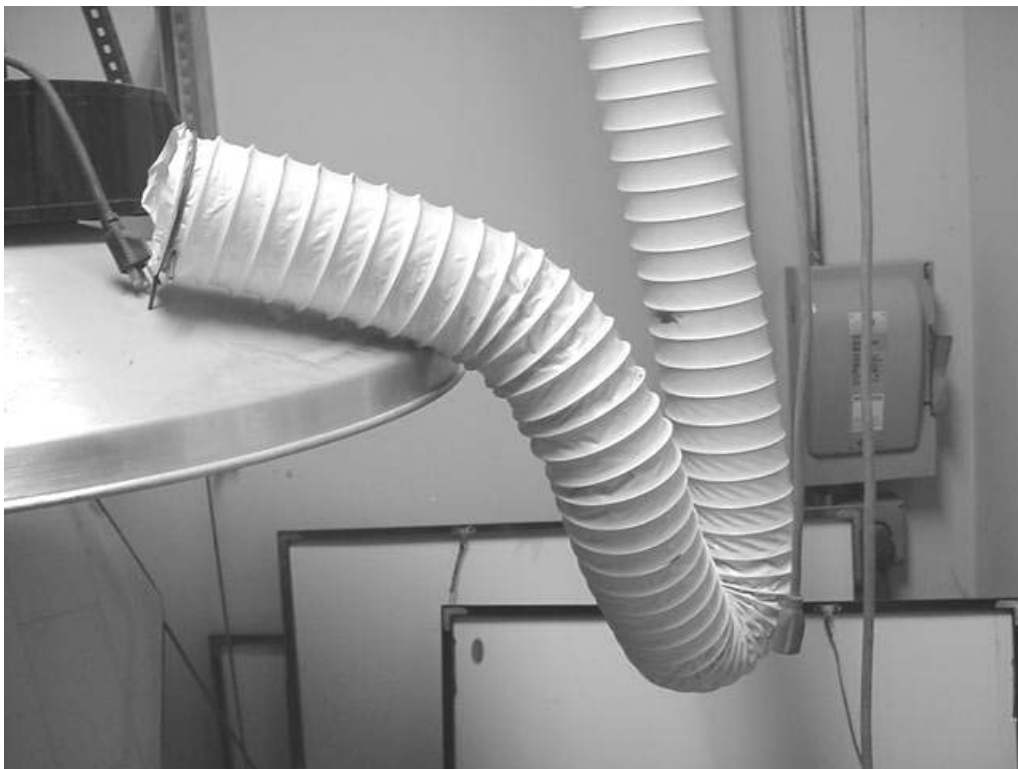
Picture 10

The art room contained a kiln that was equipped with local exhaust ventilation. However the flexible ductwork was not connected to the vent (see Picture 10). Pottery kilns can produce carbon monoxide and sulfur dioxide, which can cause respiratory symptoms in exposed individuals (McCann, M., 1985). The current condition of the kiln exhaust presents the opportunity for kiln emissions to enter occupied areas if the kiln is activated.

Flexible Kiln Duct Detached from Local Exhaust Vent

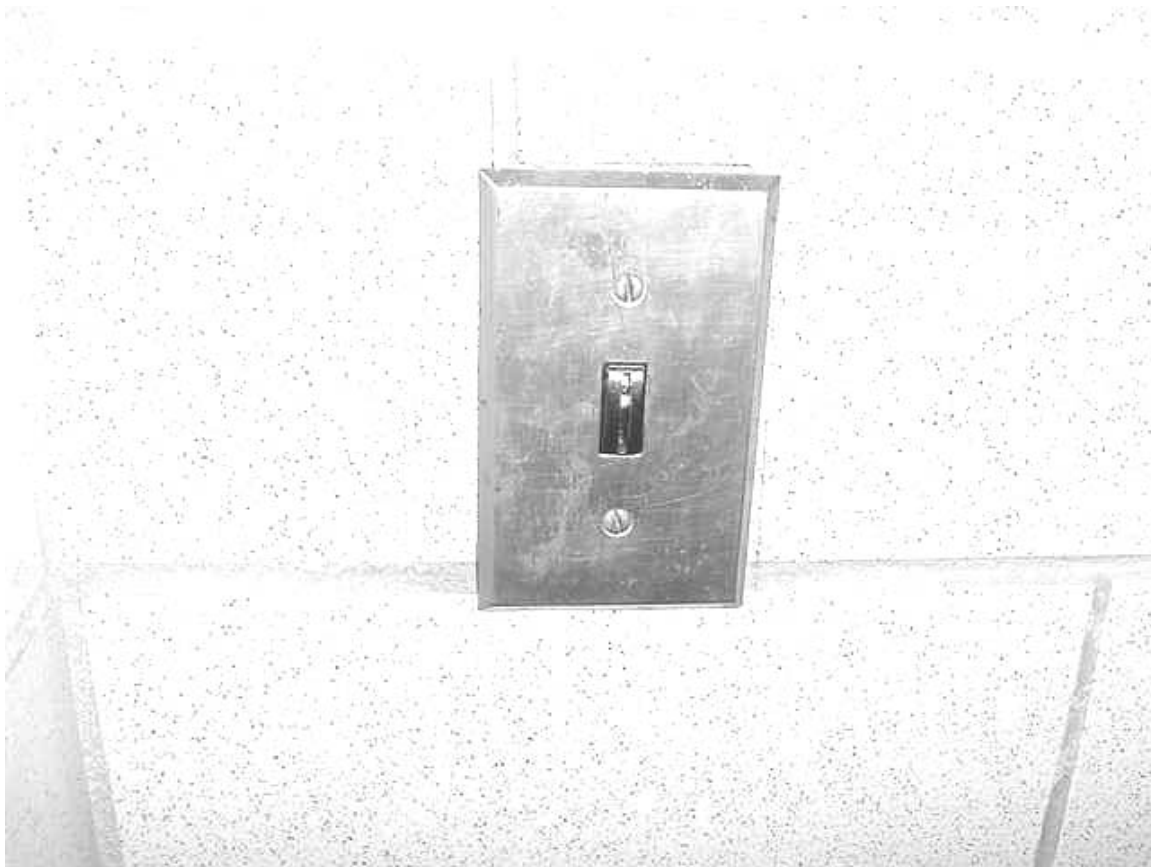
Picture 11

Example of Key Switch
